Docket No. 424 – Development and Management Plan Inspection

The Connecticut Light and Power Company Certificate of Environmental Compatibility and Public Need for the Connecticut portion of the Interstate Reliability Project.

Interim Week Inspection:

Date: November 12, 2014

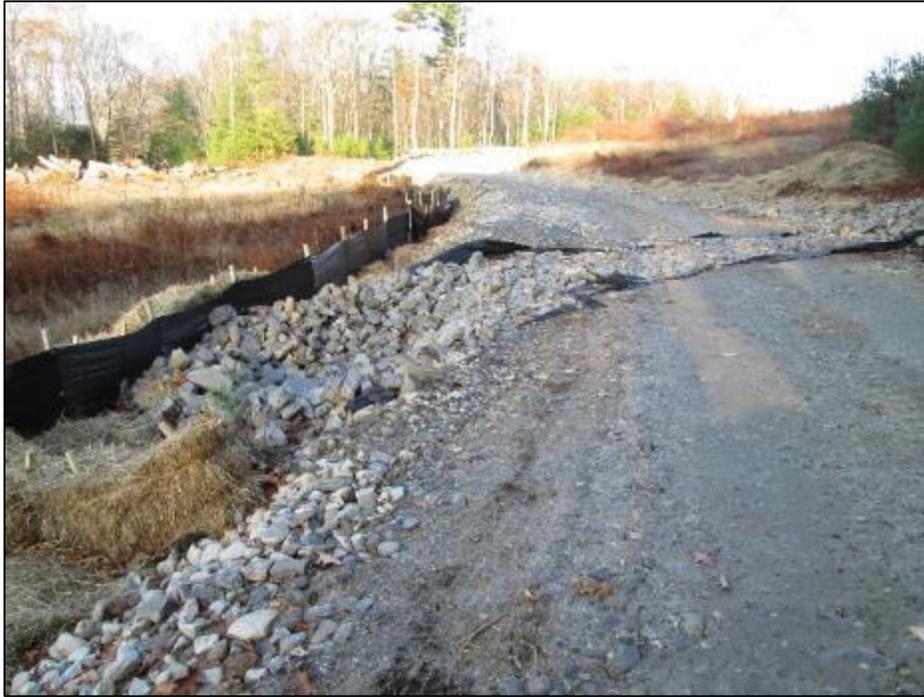
Photo #1: Observed armored water bar, plunge pool, and hay bale reinforced silt fence up-line of Str 167. (11/12)

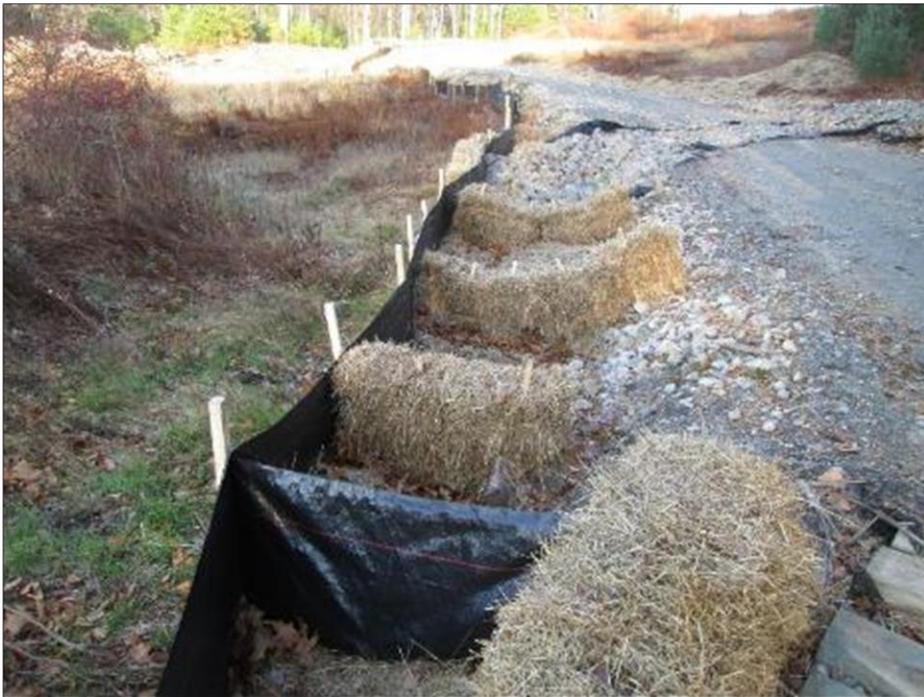
Photo #2: Observed silt fence and hay bale check dams up-line of Str 167. (11/12)

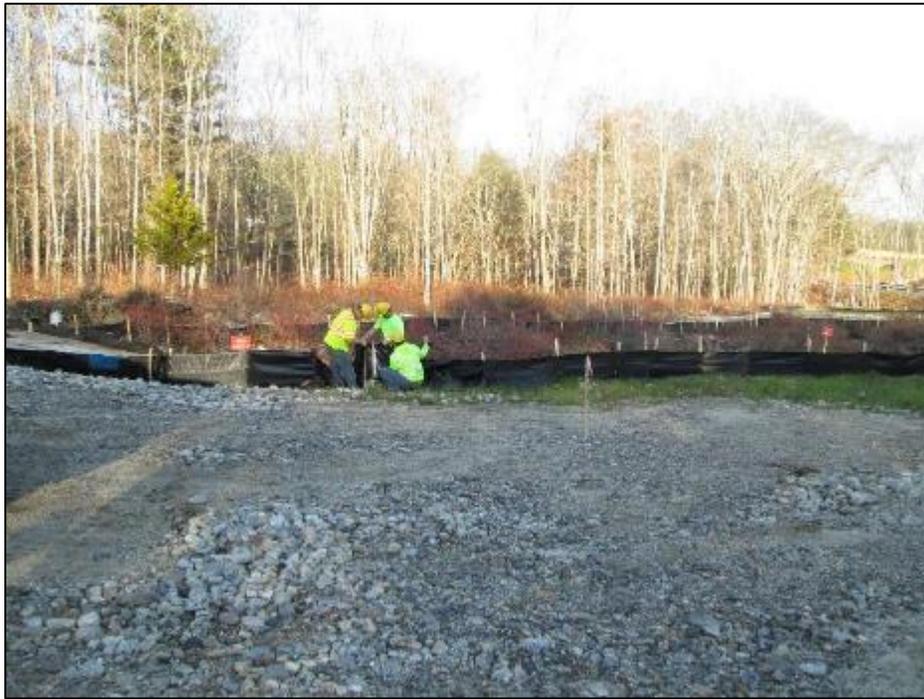
Photo #3: Observed moving and re-installing silt fence at Str 143. (11/12)

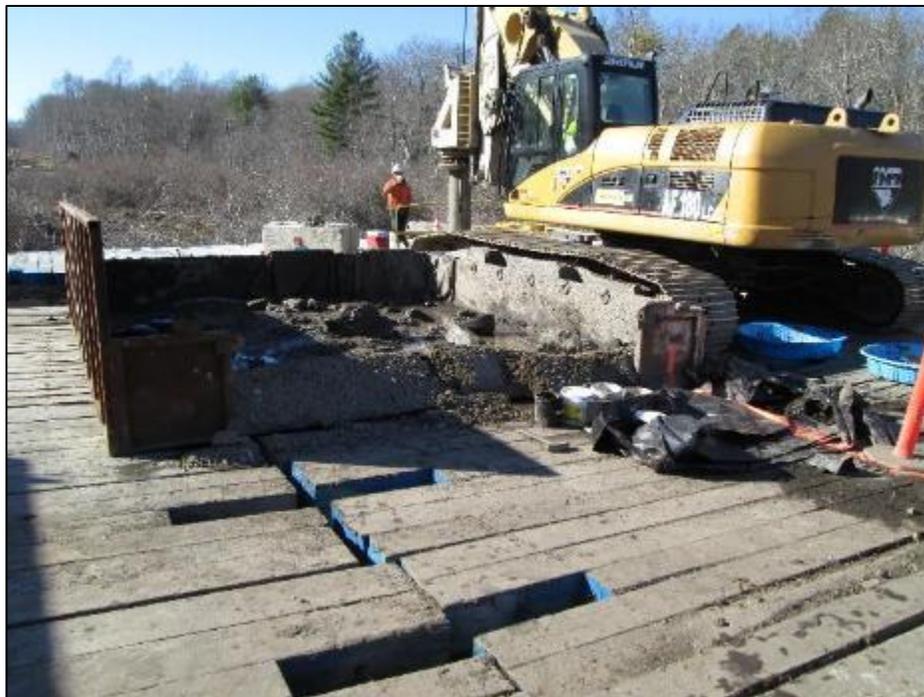
Photo #4: Spin off container and emergency spill protection under drilling machinery at Str 161. (11/19)

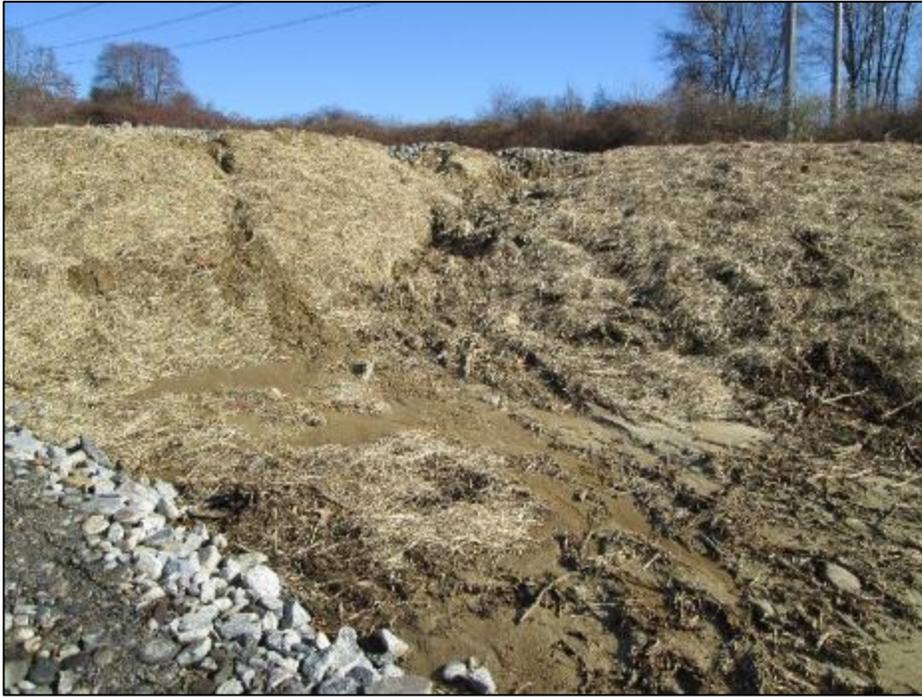
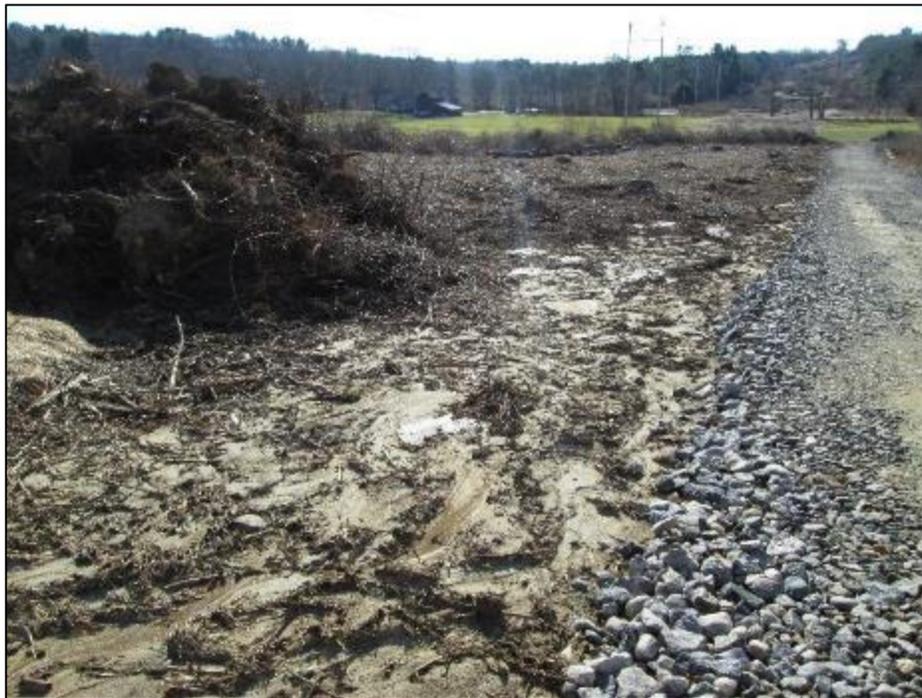
Str 284: Erosion from structure pad 284 observed in an upland area. (Photo 5 & 6) This is not considered a compliance issue.	NA	Northern intends to fix slope, remove sediment, and create preventive erosion control measures for future storms.
		Str 325: Observed spreading of hay on exposed topsoil.	Continue to follow this procedure.	NA
Inland Wetland and Watercourse encroachment and mitigation	Interim Week (11/12)	Mat installations in wetland areas are in accordance with the BMP Manual.	Continue to follow this procedure.	NA

Photo #5: A portion of Str pad 284 eroded in an upland area from Monday's storm. (11/19)

Photo #6: Extent of erosion from Str pad 284 in an upland area. (11/19)

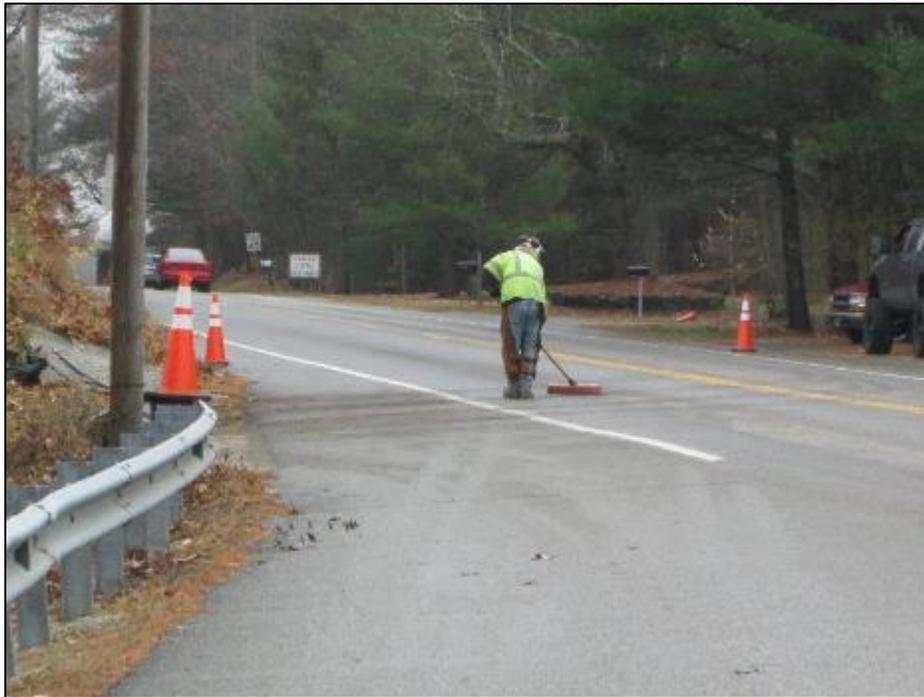
MS61, Str 307-309: Chipping brush into truck, mowing down-line of Str 308, sweeping of roadway after truck exits site. (Photo 7)

Areas of Inspection		Observation:	Recommended Action:	Corrected Action:
Access Roads and Adjacent Roadways	Interim Week (11/12)	Adjacent roadways clear and free of sediment at all visited sites. Str 309: Observed sweeping of roadway after trucks leave construction site. (Photo 7)	Continue to follow this procedure. Continue to follow this procedure.	NA NA
	Bi-Week (11/19)	Adjacent roadways clear and free of sediment at all visited sites.	Continue to follow this procedure.	NA
Vegetative Clearing Limits (Including trees to save or danger trees noted.)	Interim Week (11/12)	Project clearing observed during inspection appears to be in accordance with D & M plans. Clearing crews utilizing timber mats in wet areas to prevent unnecessary rutting.	NA NA	NA NA
	Bi-Week (11/19)	Project clearing observed during inspection appears to be in accordance with D & M plans. Clearing crews utilizing timber mats in wet areas to prevent unnecessary rutting.	NA NA	NA NA

Photo #7: Observed sweeping of roadway after truck exits site at Str 309. (11/12)

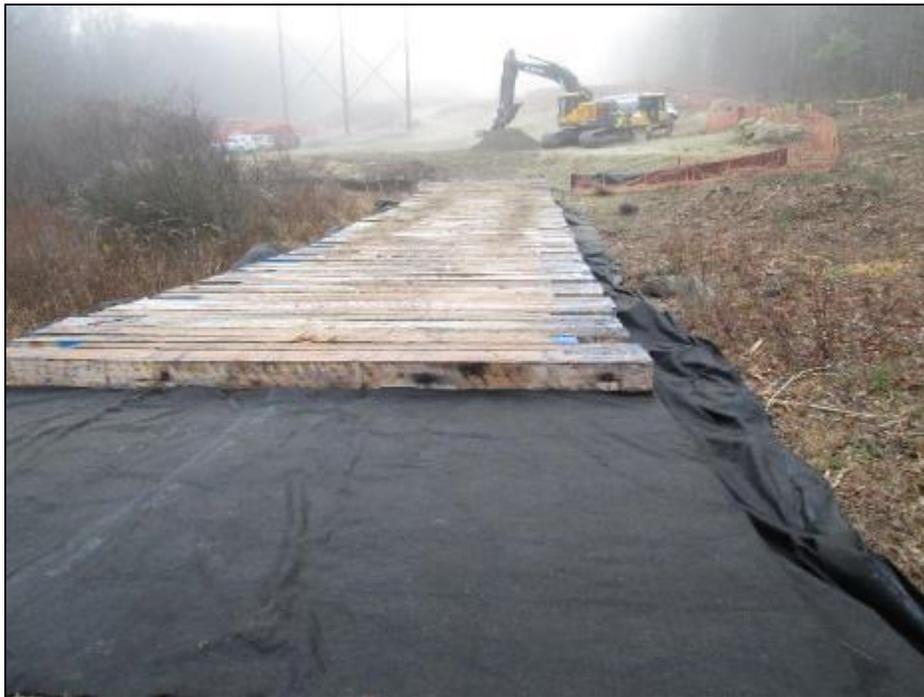
Water Crossings	Interim Week (11/12)	All crossings appear to be functioning in accordance with the BMP Manual. No sediment appears to be entering the streams or wetlands. Str 327: Observed wetland crossing with filter fabric between timber mats. (Photo 8)	Continue to follow this procedure. Continue to follow this procedure.	NA NA

Photo #8: Wetland crossing with filter fabric between timber mats up-line of Str 327. (11/12)
